Manhole Inspection Summary

Manhole # S31WW1014MH

Location Address: **5105 SAINT ALBANS WAY**

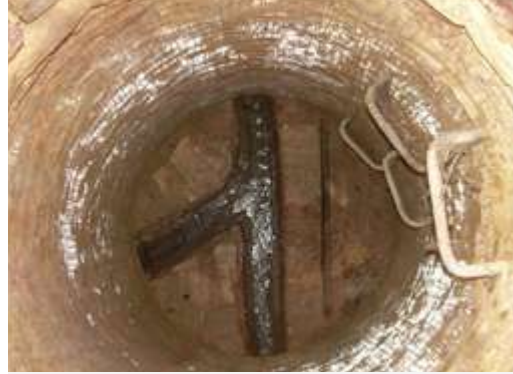
Top View

Bench debris.

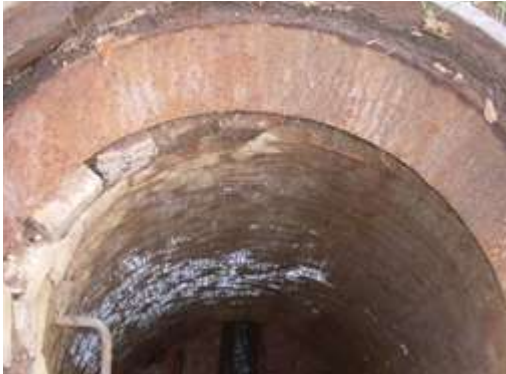
Defect

Adjustment deterioration, loose brick and infiltration. Corbel and Barrel infiltration - other side.

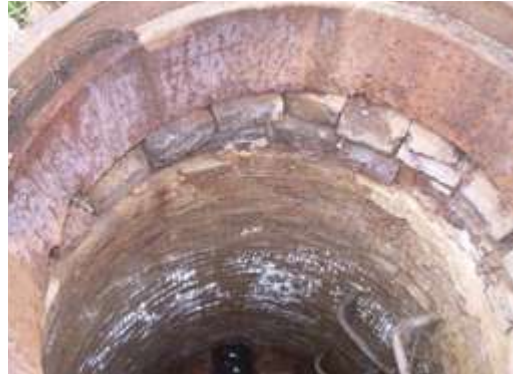
Defect

Adjustment deterioration, loose brick and infiltration. Corbel and Barrel infiltration.

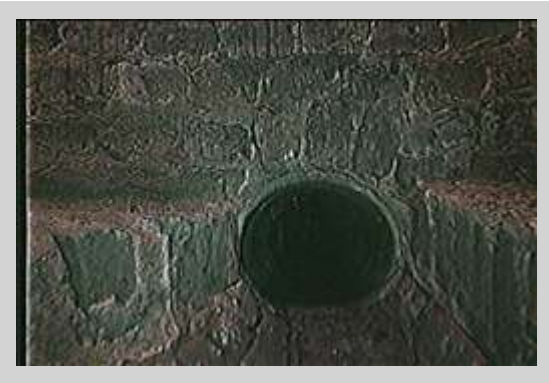
8 in. Circular Gravity Sewer Pipe Out @ 12 O'Clock

Barrel deterioration and infiltration. Channel deterioration.

Infiltration: **Evidence** Pipe Seal Cond: **Cracked**

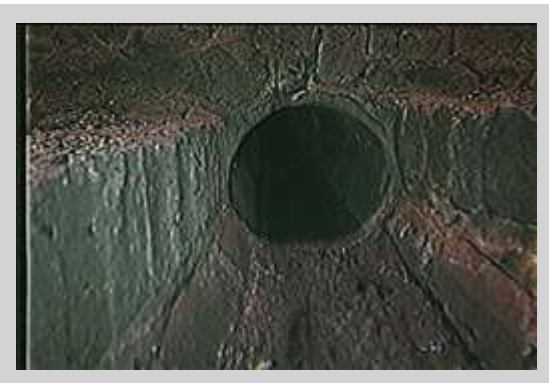
8 in. Circular Gravity Sewer Pipe In @ 6 O'Clock

Barrel deterioration and infiltration. Channel deterioration.

Infiltration: **Evidence** Pipe Seal Cond: **Cracked**

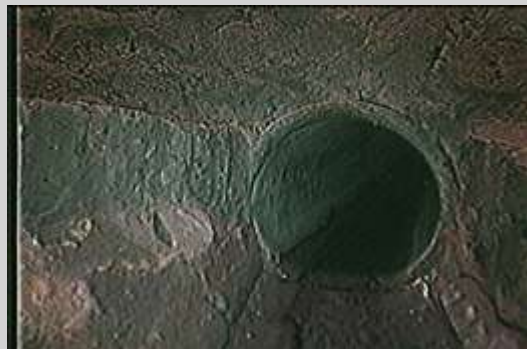
Pipe In @ 8 O'Clock

Pipe Seal Cond: **Cracked**
